# Breckenridge Condominium Association Gaithersburg, Maryland

**Building Envelope Consultants  
and Scientists, LLC.**

## Facades and General Grounds Condition Survey

### FINAL Report Phase I and Phase II

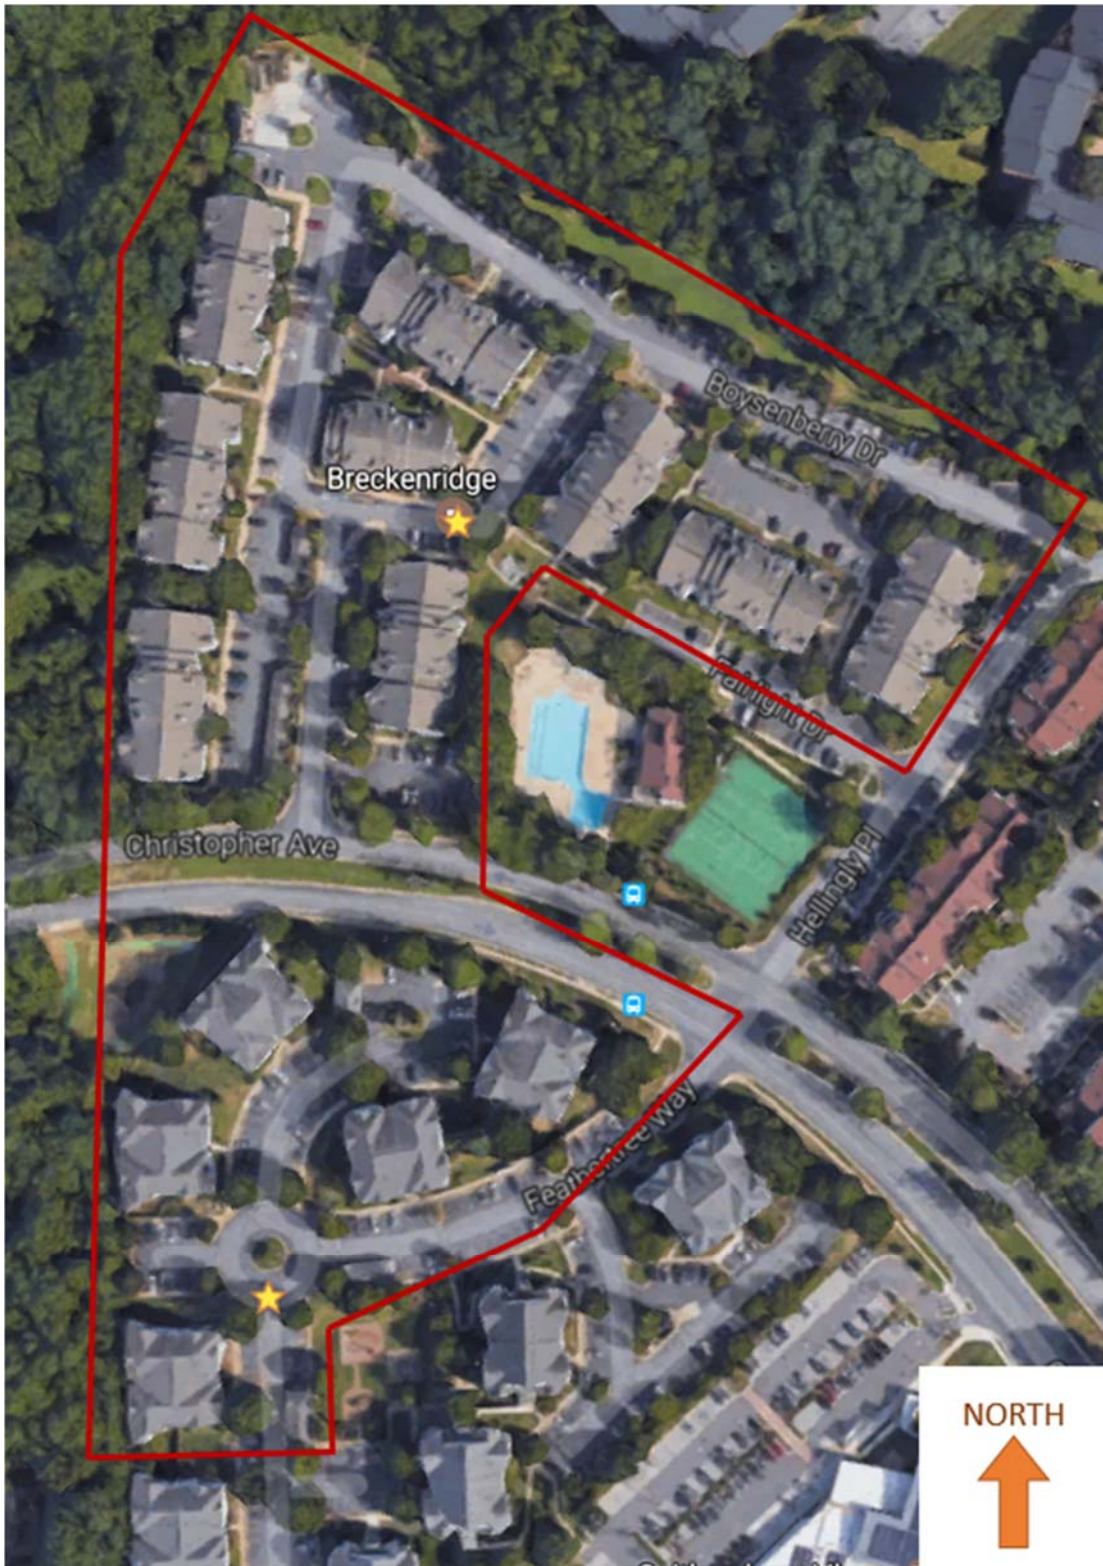
Figure 1 – Breckenridge Condominiums Key Plan and Arial Image (Google Maps).
